April 12, 2019
OKP-19-7005

RE: Structural Assessment – Existing Condition Club House Building– 45 Napier St., Kingston, ON

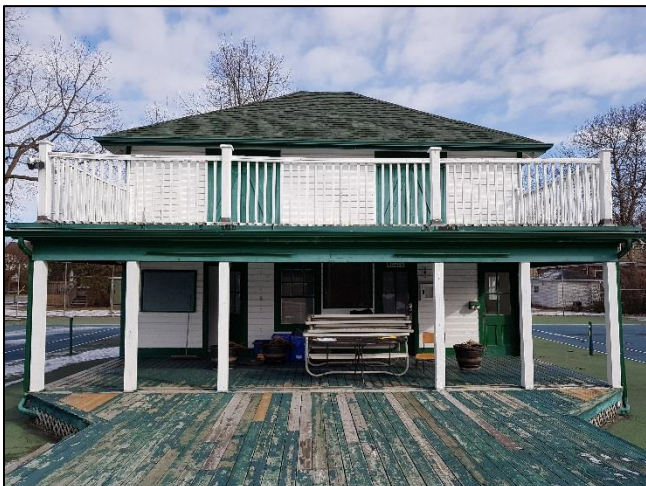
The existing building, as shown in **Photo 1**, is a two-storey structure measuring 25'-0" x 30'-0" and is multi-purpose facility primarily used as a general assembly area for tennis club patrons and staff. The original club house was constructed circa 1920's and has since undergone minimal renovations and alterations. One notable renovation which took place after original construction is the construction of a 15' x 30' storage shed off the rear of the club house, as shown in **Photo 2**. Note that at the time of the site visit the building remained unheated during winter months.

Photo 1: Original Main Building

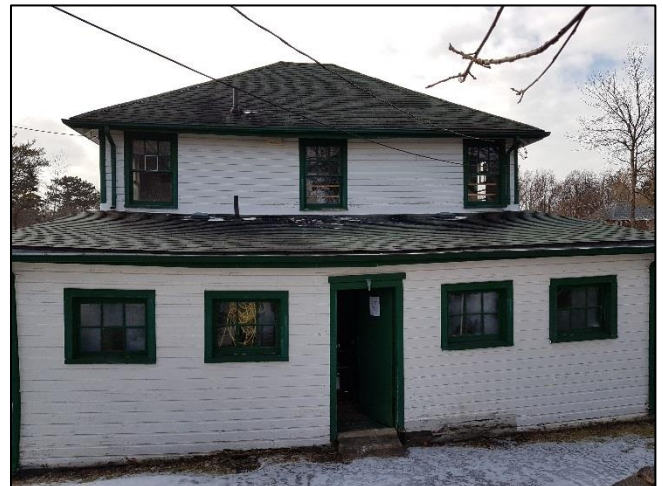
Photo 2: Rear Storage Shed Addition

The observed construction methodology is common to the time period in which it was originally constructed. The floor joist to stud wall connections provide lateral restraint to the balloon framed stud walls. In general there are no significant deficiencies observed in construction methodology and/or signs of physical damage/excessive deflection that would raise concern at the present time. Locally along the rear exterior wall of the building differential settlement and inwards shifting is observed. These effects are also noticeable on the interior of the building; the wall trim can be seen detaching from the ceiling and the windows will no longer open due to their unsquared frames. It is in our opinion that this has been caused by the combination of the aforementioned deficiencies in the foundation structure and the construction of the rear storage shed addition, which took place after original construction of the main building. The following are contributing factors for the observed movement in this area:

- Roof rafters of new addition are loadbearing at the top of the ground floor wall,
- Floor joists of new addition are loadbearing at the bottom of the ground floor wall,
- The foundation along the front of the new addition is observed to be settling independent of the main building, causing an outwards pull on the ground floor wall,
- The presence of the chimney (with larger foundation) at the north-west corner of the building provides rigidity to only one side of the exterior wall, resulting in unequal support,
- Potential differences in subgrade materials between the front of the building and the rear.

In order to rectify the observed damage and mitigate future damage it is recommended that the rear storage shed be removed. This will alleviate the excess load on the rear wall and allow access to the foundation in this area. With access to the foundation in this area the wall can be jacked up, made level/plumb and new properly engineered continuous footing can be constructed beneath it down to shallow bedrock.

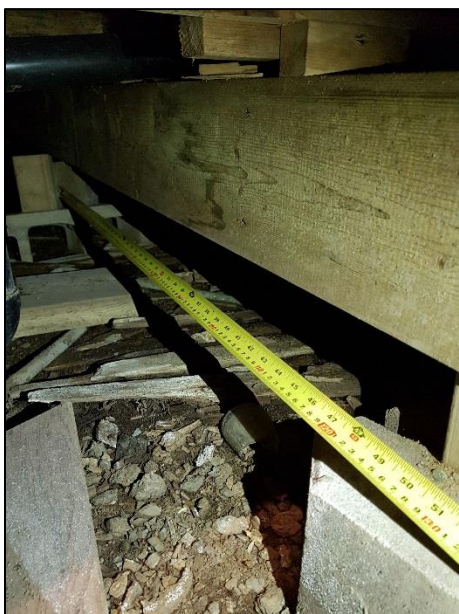
There exists a small trap door into the crawlspace below the ground floor. From this trap door the crawlspace is too confined to provide full access to observe the entire foundation structure. It can be observed, however, that the building rests on an unconventional foundation constructed of various concrete blocks which form an approximate 4'-0" to 6'-0" grid on the grade below. **Refer to Photo 3.**

Photo 3: Existing Foundation

Not all foundation elements were exposed and/or accessible at the time of the site visit. What was observable at the foundation level does not meet the requirements of the 2012 Ontario Building Code for various reasons including insufficient frost protection/waterproofing and inadequately sized footings for bearing capacity of underlying soil. These deficiencies can cause both short term and long-term effects on the foundation. Due to the relative age of the building it is believed that all expected long-term settlement has occurred, however, periodic fluctuations in moisture content and temperature can cause ongoing settlement and heaving issues for the life of the building. It is recommended that measures be taken to insulate/waterproof the underside of the building to protect the footings as well as the existing utilities. In addition, new eaves troughing is recommended to adequately collect and discharge water out and away from the building footprint.

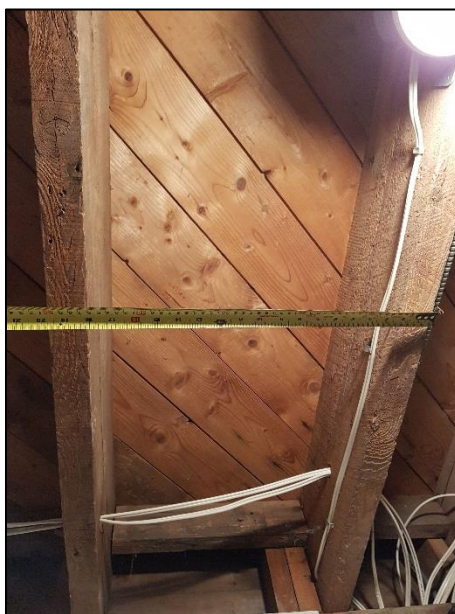
Between these concrete blocks at the foundation span 3ply 2x8 built up floor beams supporting the ground floor joists. These beams span in the E-W (side-to-side) direction. The ground floor assembly consists of 2x10 floor joists spaced at 18" c/c, spanning N-S (front-to-back), covered in wood plank decking. The main support for the second floor consists of a single centrally located 4ply 2x12 built up floor beam supporting the second floor joists. This beam spans 25'-0" in the N-S direction with one intermediate support at midspan, which was not exposed or accessible at the time of the site visit. The second floor assembly consists of 2x10 floor joists spaced at 18" c/c, spanning E-W, from exterior stud wall to central floor beam. Similarly, the second floor is covered in wood plank decking. **Refer to Photo 4.**

Photo 4: Existing Floor Assemblies

The observed construction methodology is common to the time period in which it was originally constructed. The floor joist to stud wall connections provide bearing to the floor joists. The current spans of simply supported floor joists of 15'-0" exceed the maximum allowable for 2x10 @ 18" c/c within assembly areas. Similarly, the current spans of the floor beams of 12'-6" exceed the maximum allowable for 4ply 2x12 built up wood beam within assembly areas. The specified design live load for assembly area occupancies is 4.8 kPa [100psf] as per the 2012 OBC. These deficiencies shall be rectified by reinforcing the existing floor with additional joists and adding additional support posts/beams.

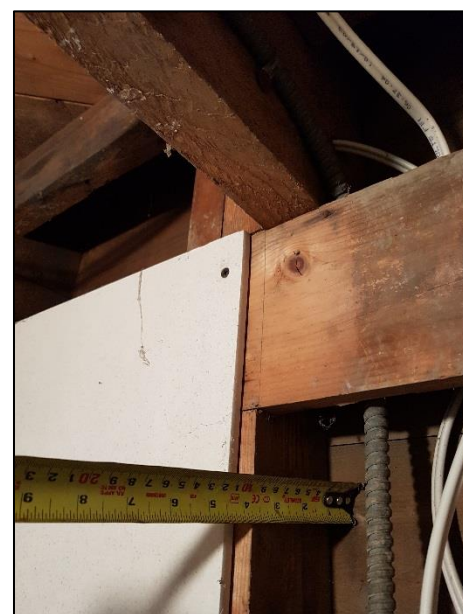
Photo 5: Typical Joist to Stud Wall Connection

The exterior stud walls are constructed of 17'-0" tall full height balloon framed 2x4 studs spaced at the same 18" c/c as the floor joists. This type of construction is common to the time period in which it was originally constructed. Around the entire perimeter of the building are longitudinal 1x6 members notched into the interior face of each 2x4 stud. Nails can be seen fastening the joists to both the 2x4 studs and 1x6 plate at all of the locations observed. These connections provide both bearing connection to the floor joists and lateral restraint to the stud walls. **Refer to Photo 5.**

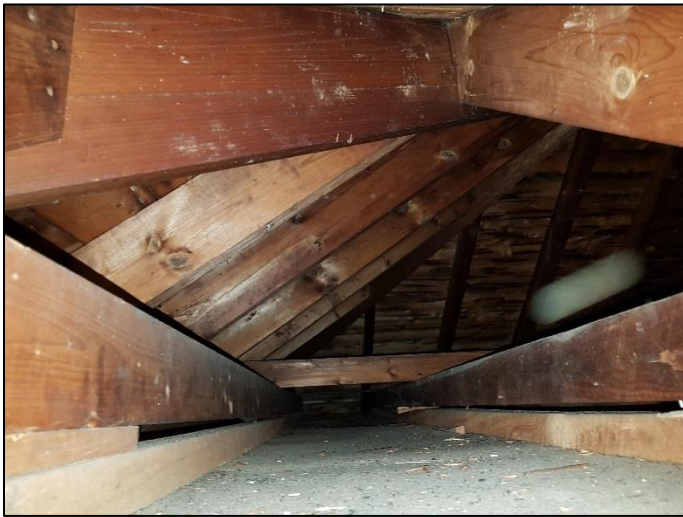
The roof consists of a conventionally wood framed hipped roof construction, with primary common rafters spanning N-S. The rafters are 2x6 rafters spaced at 20" c/c, bird mouth notched at the top of walls transitioning into 2'-0" exterior overhangs all around. The roof bears only on the four exterior walls. In addition, collar ties can be observed to be installed at each rafter within the ceiling cavity. **Refer to Photo 6.** The roof is finished with 1x6 wood decking and asphalt shingles.

Photo 6: Existing Roof Construction

The existing roof assembly is deemed to be satisfactory condition, with the exception of the damage/deflection caused by the movement in the rear exterior wall. There are no other significant deficiencies observed in construction methodology and/or signs of physical damage/excessive deflection. There are no immediate concerns in regard to the structural integrity and safety aspects of the building at the present time. There are some signs of water infiltration within the acoustic ceiling tile on the interior. It is recommended that roofing be repaired/replaced, as needed, in deficient areas – to be monitored by Owner.

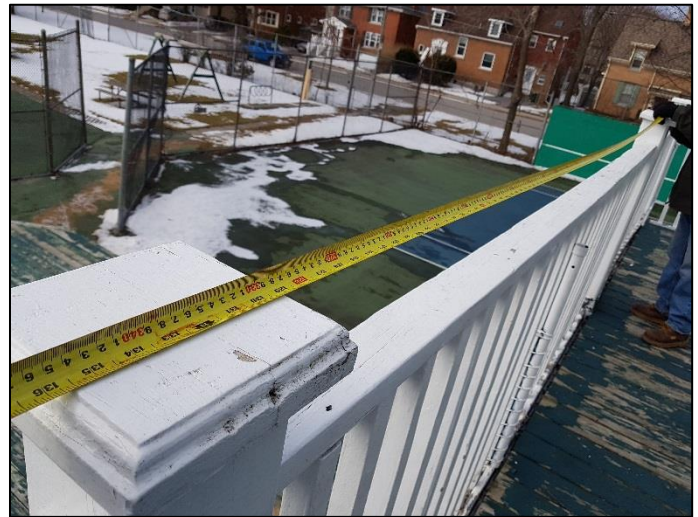
Photo 7: Existing Wood Guards Surrounding Deck

The guards around the deck are constructed with 6x6 wood posts positioned directly above the structural posts below, **refer to Photo 7**. From the underside they can be seen protruding through the decking down to the beams below where they are surrounded by full blocking and fastened to prevent rotation by lag bolts in each. Guard rails are 42" high and pickets are spaced such that gaps do not exceed 4" in all locations (**Photo 8**).

The existing deck construction is deemed to be in satisfactory condition. There are a couple deficiencies in the current construction of the guards causing immediate safety concerns. Lag bolts in various locations are observed to be missing the base of the 6x6 guard posts and the 11'-0" spans between guard posts, as measured, exceed the maximum allowable guard rail spans as per the 2012 Ontario Building Code. All other dimensions are found to be in accordance. It is recommended that the existing guard posts be reattached with adequate connection at there base and new posts be installed at midspan such that no guard rail spans exceed 5'-6". With this exception of the above, there are no significant deficiencies observed in construction methodology and/or signs of physical damage/excessive deflection. The current spans of the structural joists and beams do not exceed the maximum allowable spans within assembly areas.

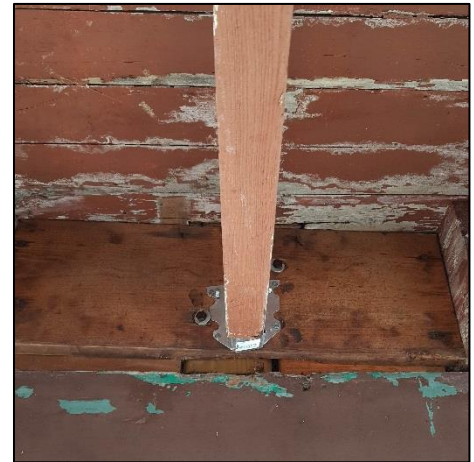
Photo 8: Typical Guard Post Connection
